**RECONSTRUCTING THE ASSEMBLAGE OF IRON ARTIFACTS FROM THE  
LATE HELLENISTIC SHIPWRECK AT KIZILBURUN, TURKEY**

A Thesis

Submitted to the Office of Graduate Studies of  
Texas A&M University  
in partial fulfillment of the requirements for the degree of

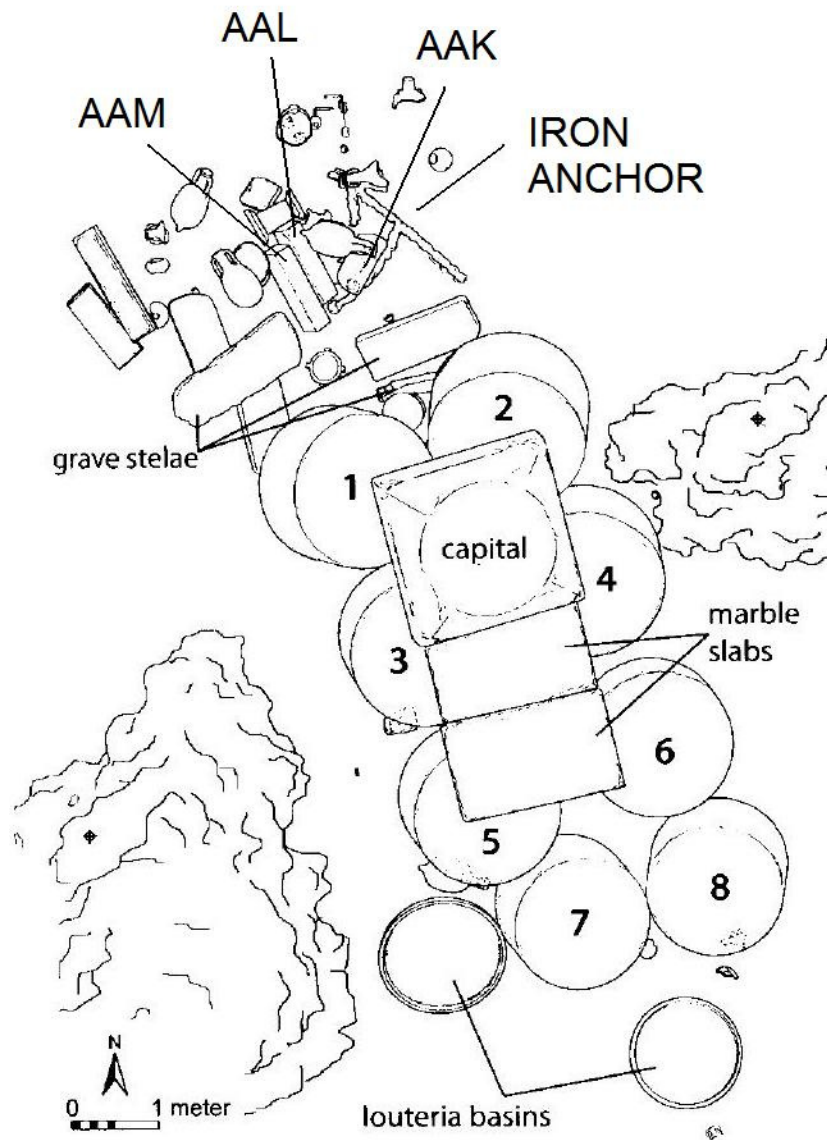
Fig. 1.1: Plan of the Kızılburun shipwreck in 2005 before the first season of excavation (from Carlson and Aylward 2010, Fig. 3; drawing by S. Matthews, used with permission from INA).

When the excavation began in 2005, a site plan was produced, showing a portion of the shank visible on the surface of the sand, although at the time, the identity of the artifact had not been verified. Each of the column drums was given a unique designation, numbers 1 – 8, and the upslope area was divided into four quadrants, areas 17 – 20, with the odd numbers on the western half of the site and the even numbers on the eastern half (Fig. 1.2). **AN 1** was found in area 20, just upslope of Drum 2. As it was being excavated, a large protrusion was unearthed perpendicular to the shank, intersecting it near its middle. Identification of concreted iron objects is practically impossible on site, and during excavation it was theorized that this system of concretions was one piece of equipment, such as a bilge pump or part of the lifting mechanism for the drums. Only after the sections were studied in the lab was it decided that the two perpendicular pieces were two separate objects, representing the anchor and its detachable stock (**ST 1**).

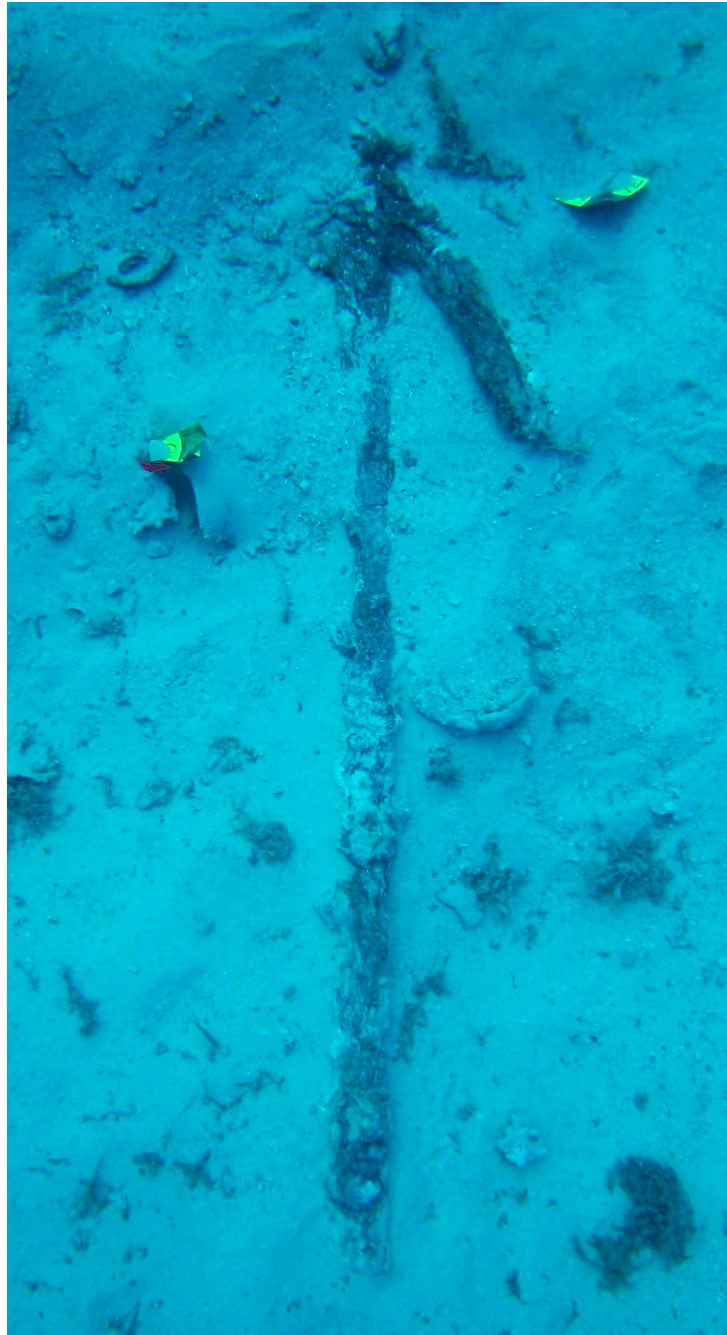
Fig. 1.3: The initial exposure of the anchor concretion in situ on 9 July 2005 (photo by D. Carlson).

The first note of the anchor concretion in the divers' logs occurred 27 June 2005 when Dr. Faith Hentschel noted the presence of the large metal shaft in area 20 (Fig. 1.3). Her initial thought was that the object was an intrusive Byzantine anchor of the cruciform type found on the Yassiada 7<sup>th</sup>-century C.E. shipwreck, but with broken arms.<sup>9</sup>

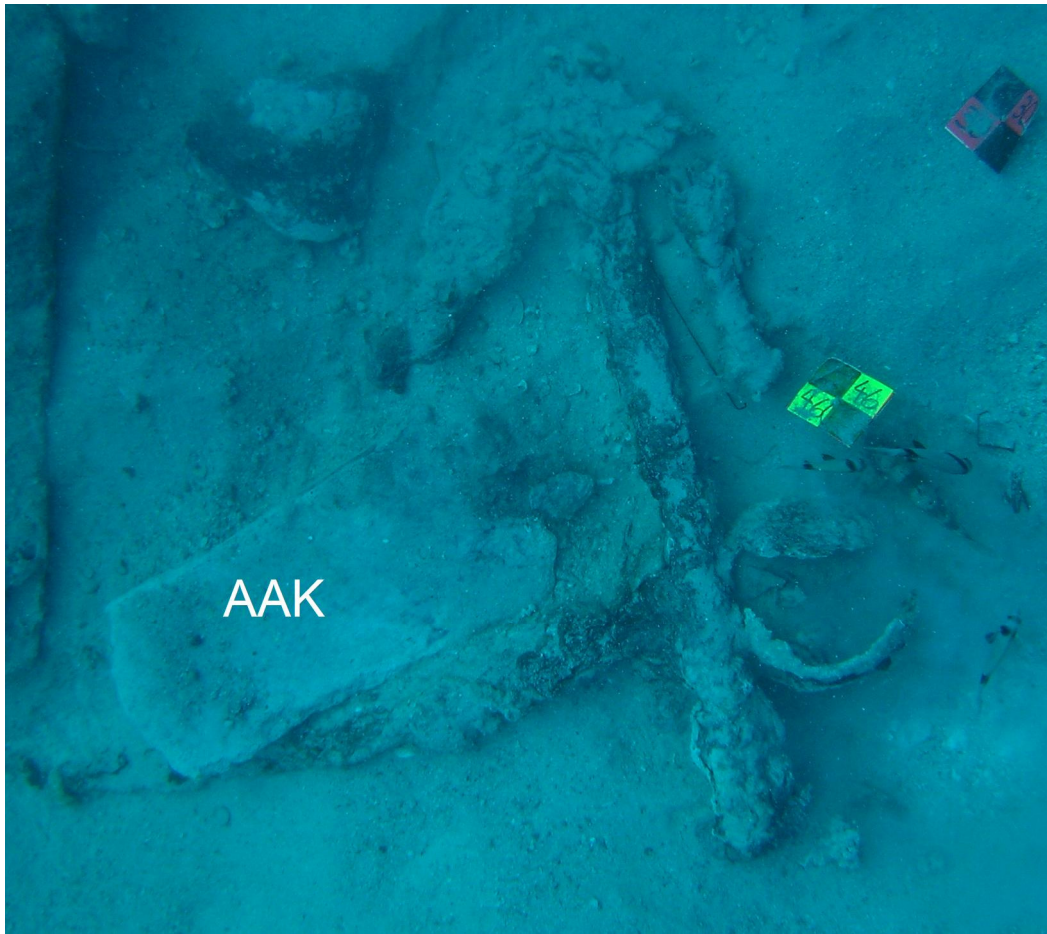
Fig. 1.4: During the excavation of the perpendicular extension and following the removal of section ABX-1 from the anchor concretion on 27 July 2005. Marble block AAK is visible at left (photo by D. Carlson).

On 26 July 2005, the first section of the concretion was raised. ABX-1 (Lot 205) consisted of the portion nearest Drum 2. That same day, the perpendicular extension was discovered. This “arm,” so-called in contemporaneous dive logs, extended beneath the lower edge of an adjoining marble block, AAK (Fig. 1.4). Given this association, it seemed probable that the iron concretion was part of the cargo or machinery and not intrusive as initially proposed. It was also postulated that the concretion and the extension represented two anchor shanks perpendicular to each other. At a depth of 45 meters, bottom time was limited to 20 minutes of work per dive, which leaves very little time for on-site evaluation. At such an early stage in the excavation, no idea was discredited.

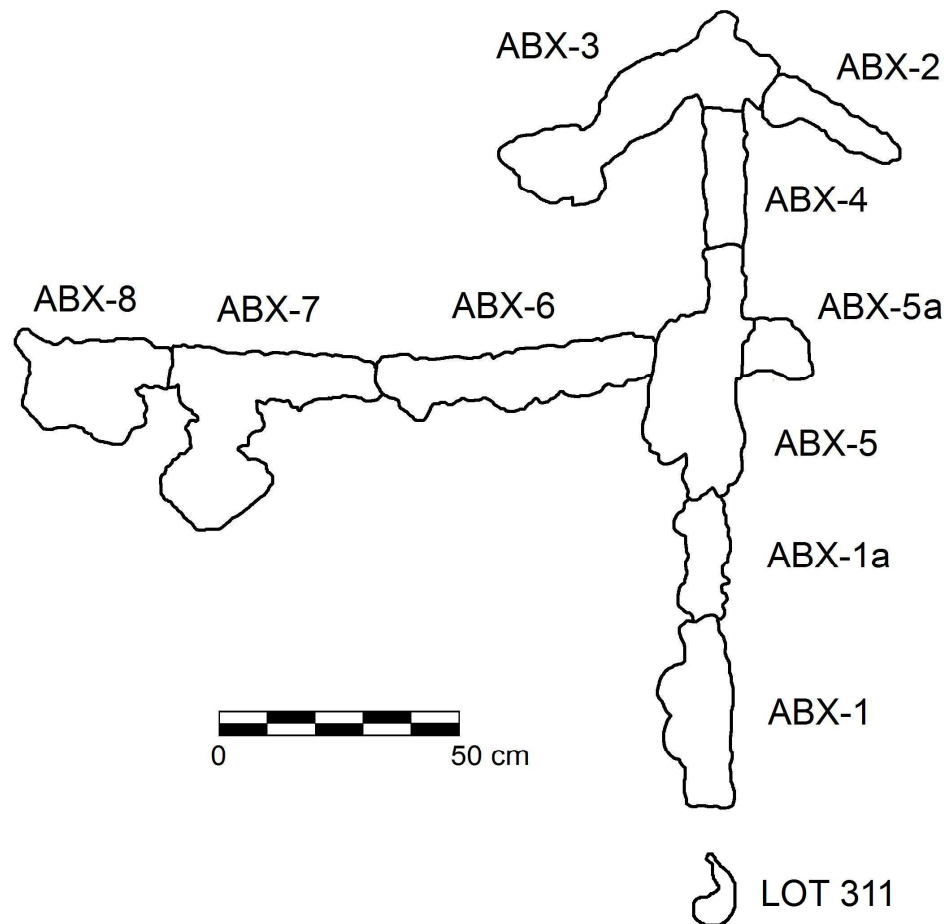
Fig. 1.5: Sections of ABX and Lot 311 as they appeared on the seabed.

concretion. Four days later, he was able to raise ABX-5, ABX-5a, and ABX-6. ABX-5 (Lot 367) was the central part of the anchor's shank and the largest fragment of the concretion. ABX-5a (Lot 367.01) was a small bulbous concretion attached near the midpoint of the shank, and ABX-6 (Lot 370) was the portion of the extension which attached to ABX-5. August 18 marked the removal of the final two pieces from the sea floor: ABX-7 (Lot 386) and ABX-8 (Lot 387), which constituted the middle and westernmost end of the extension, respectively (Fig. 1.5).

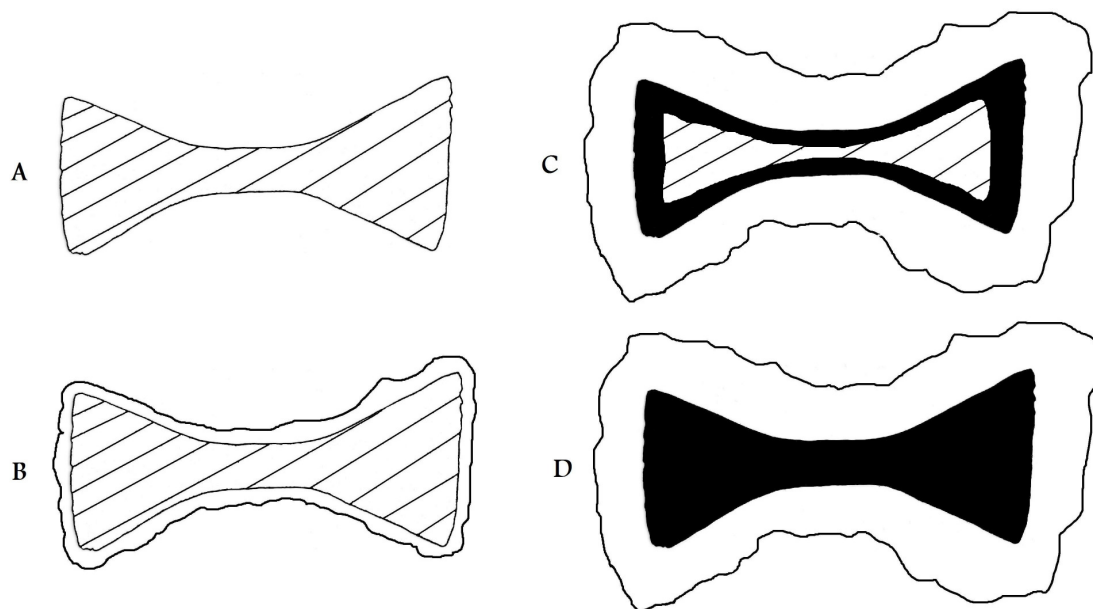
Fig. 1.6: Corrosion of iron and the formation of an encompassing concretion. A. Iron object remains metallic following deposition. B. Concretion layer begins to form at surface. C. Concretion thickens while iron begins to degrade. D. Iron completely reduced to black powder corrosion product within dense concretion but surface of object retains shape (drawing by author).

Iron corrosion in water is a complicated process and not at all uniform. After 2000 years, it can be assumed that most iron has long ago disappeared. Active corrosion occurs when ions migrate away from the metal toward its deposition environment, leaving the object vulnerable to further decay. This process is behind the formation of a concretion and the total loss of original metal resulting in an inner hollow, as described above. Occasionally, however, some iron remains metallic within its concretion, and another explanation must be considered for the reasons behind its survival. Passivation occurs when ions from the object react with anions in the environment to form a protective layer, shielding the artifact from further corrosion, which usually depends on the pH as well as energy found at the site,<sup>16</sup> for example the energy of the varying currents at Kızılburun. Unfortunately, a summation of the processes leading either to corrosion or to survival is not that simple, since not all of the contributing factors facilitating deterioration are known,<sup>17</sup> especially for a period of time spanning two millennia. Upon discovering an artifact that has somehow avoided deterioration, it can be assumed that the usual factors guiding an object toward corrosion are absent,<sup>18</sup> or that the metallic object may be intrusive on a site where most other iron corroded. In the following chapters, each object is discussed with regard to its individual state of preservation and what steps were taken to conserve and reconstruct it.

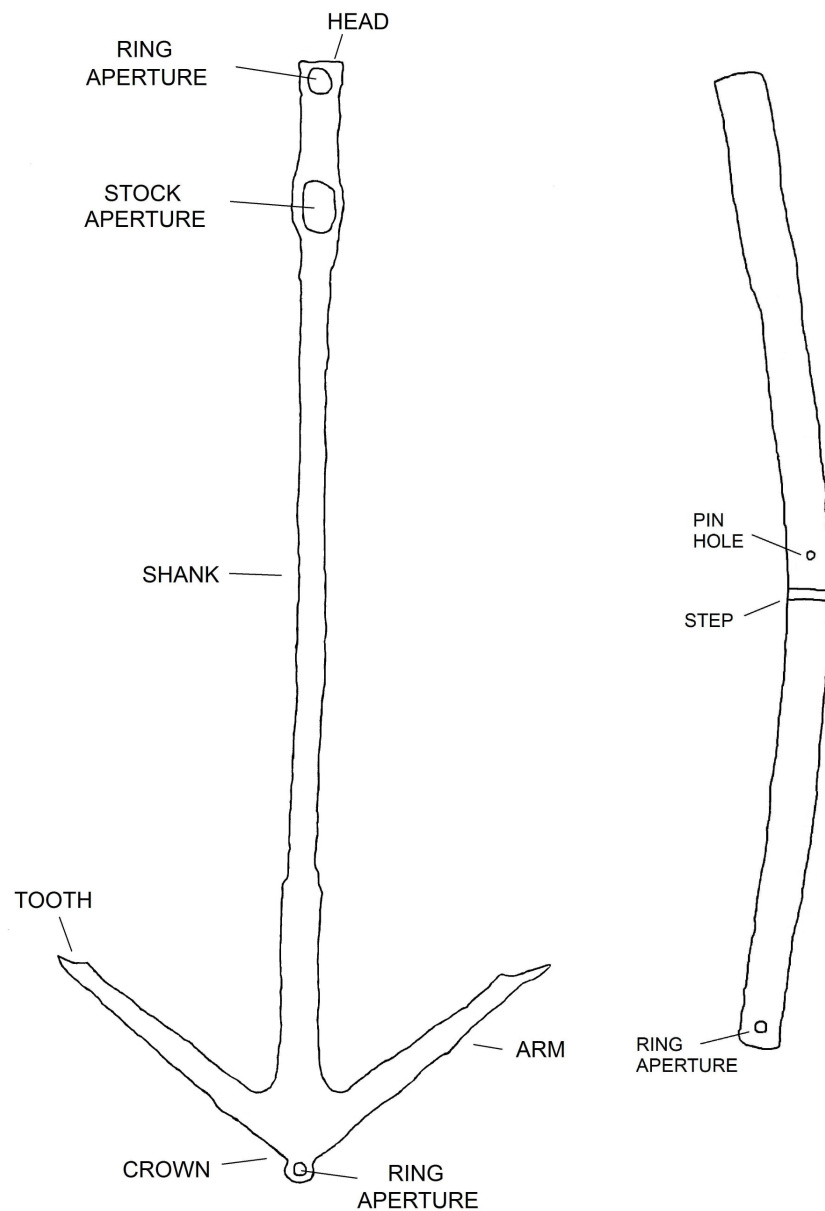
Fig. 2.1: Components of an ancient iron anchor (left) and its stock (right) (drawing by author).

the anchor, called the crown. Another ring aperture at the crown is meant for a ring through which ran an additional line to disengage the anchor from the seabed.<sup>20</sup>

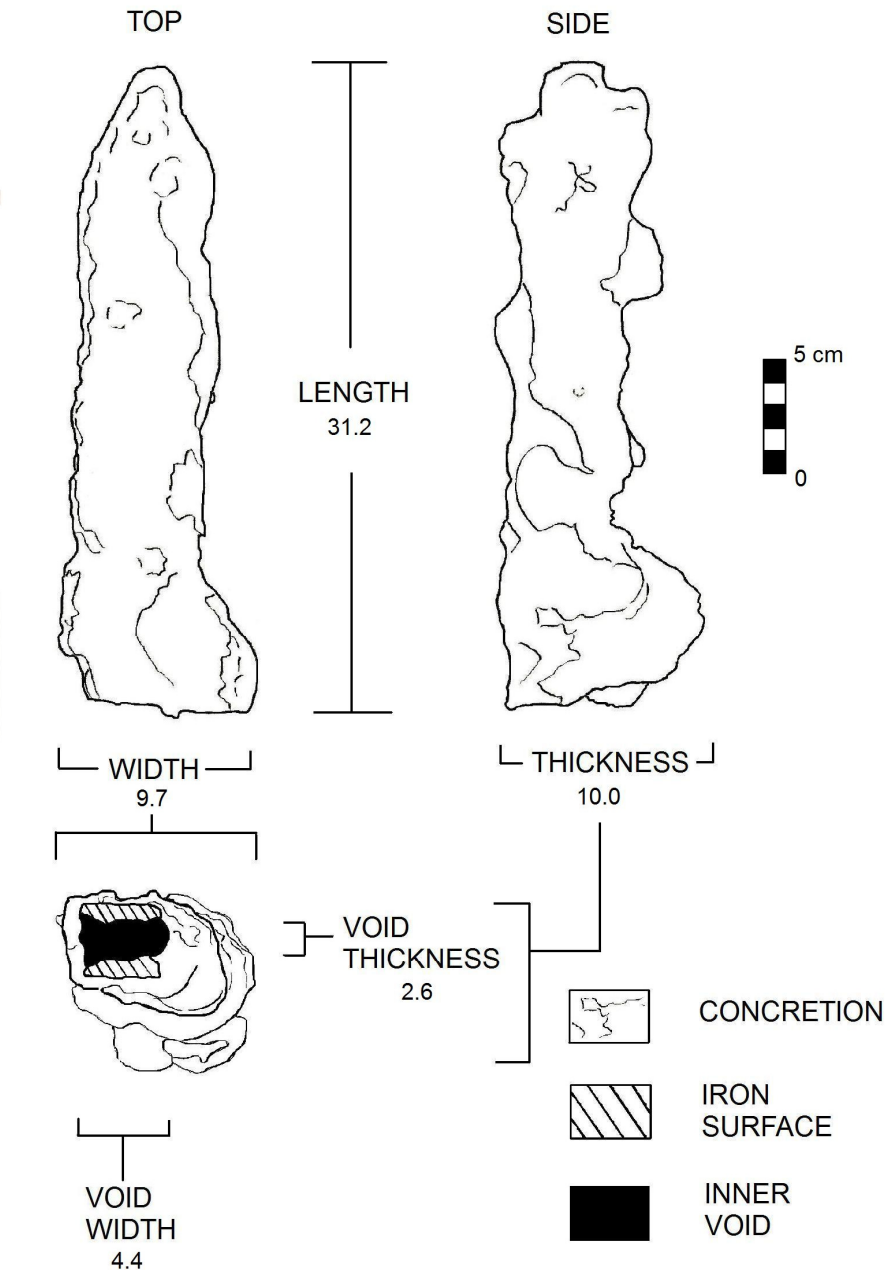
Fig. 2.3: Example of drawing for concretion section ABX-2 and how measurements were taken. Dimensions in cm (drawing by author).

Each concreted fragment was sketched in detail to provide an idea of the shape and extent of the encrustation (Fig. 2.3). The drawings were useful in studying the change in shape of the actual anchor and how that was reflected in the cross-sections of the concretion fragments. Measurements were noted for the individual sections including the overall length, the maximum width, taken across the top of each fragment as it appeared on the seabed, and the thickness. At every break between sections, the object void was measured, (Table 2.1), and in some cases the cross-sectional shape could be

described as either distinctly rectangular or octagonal, characteristics important in determining the approximate age of the anchor.

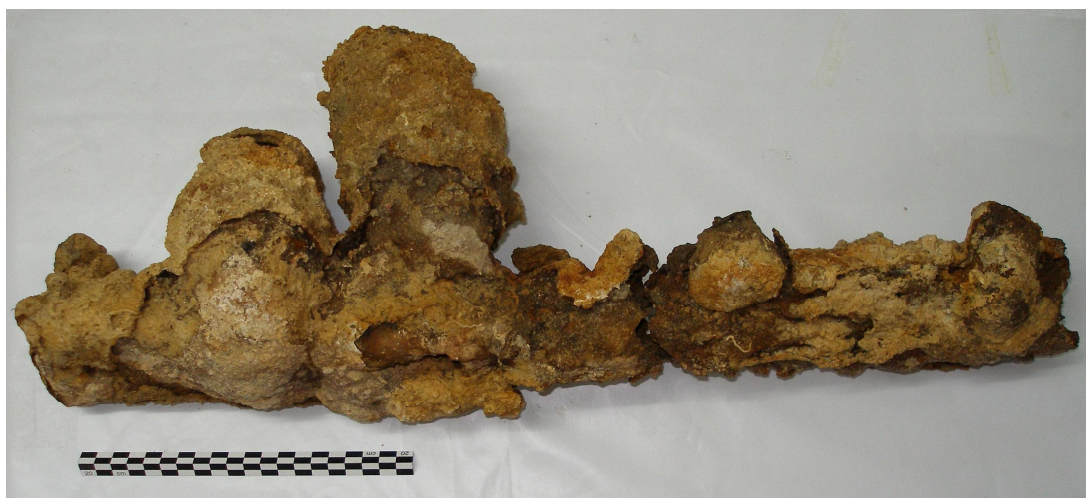
Fig. 2.4: ABX-1 (left) and ABX-1a (right).

During this initial cataloging process, it was discovered that there were more sections present than there had been in the field. ABX-1, the uppermost portion of the anchor, originally in one piece, was in two pieces when studied in the laboratory (Fig. 2.4). The largest section remained ABX-1 while the smaller of the two was given the label ABX-1a to distinguish the two sections from each other in note-taking during the conservation process. Although detached, ABX-1a joined very snugly to breaks in both ABX-1 and ABX-5. ABX-1 had a small indentation, thought to be a hole intended for the attachment of a ring, as well as a rectangular hollow, which appeared to be the heavily concreted opening meant to hold the detachable stock, penetrating the concretion. In addition, the iron had developed large globular encrustation on the underside, which was hoped to contain remnants of the anchor's ring.

ABX-1 and ABX-1a at first sight appeared complicated as well as diagnostic, being that the cross-sections of the two concretion sections forming the very top of the anchor were vaguely hexagonal or octagonal in cross-section, as was the break joining ABX-1a to ABX-5. Recalling the bronze anchor on display in the Bodrum Museum of Underwater Archaeology, it seemed that this could be an important piece of information in identifying this anchor type. The colossal bronze anchor has an octagonal cross-section through its midsection, although through the upper shank and near the juncture of the arms and crown, the section changes to a rectangular shape. It seemed that the Kızılburun anchor mimicked the Bodrum bronze anchor in that regard. Both ABX-1 and ABX-1a were full of sediment but appeared largely hollow, in that the only metal remaining were the exterior layers of the anchor's surface.

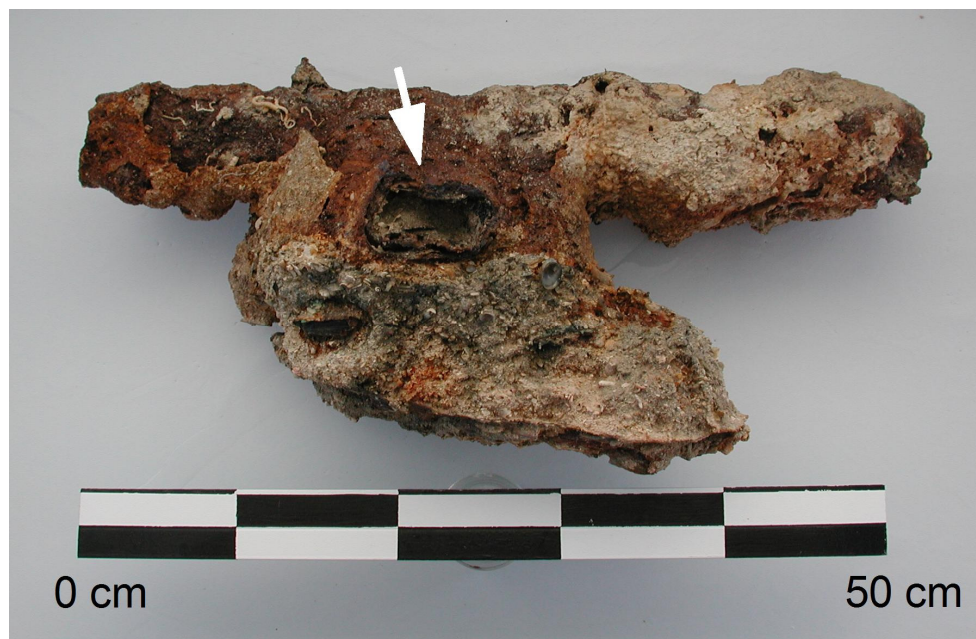
Fig. 2.5: ABX-5, in profile, showing detail of connection to anchor stock (ABX-6) (photo by J. Levin).

ABX-5 (Fig. 2.5) was the conjunction of the anchor and the stock, and because of the intersection of so much iron, the concretion around this piece was substantial.<sup>24</sup>

Studying ABX-5 more closely, it was clear that the anchor and stock abutted, with the stock concreted to the underside of the anchor shank. The cross-section at the break joining ABX-4 revealed a combination of corrosion and concretion within the break: a dense concretion layer, a sandy layer, and a metallic layer. The distinct facets of the octagonal shape were also visible in the interior. Although it was open at both ends, there was sand densely compacted in the innermost areas of the void.

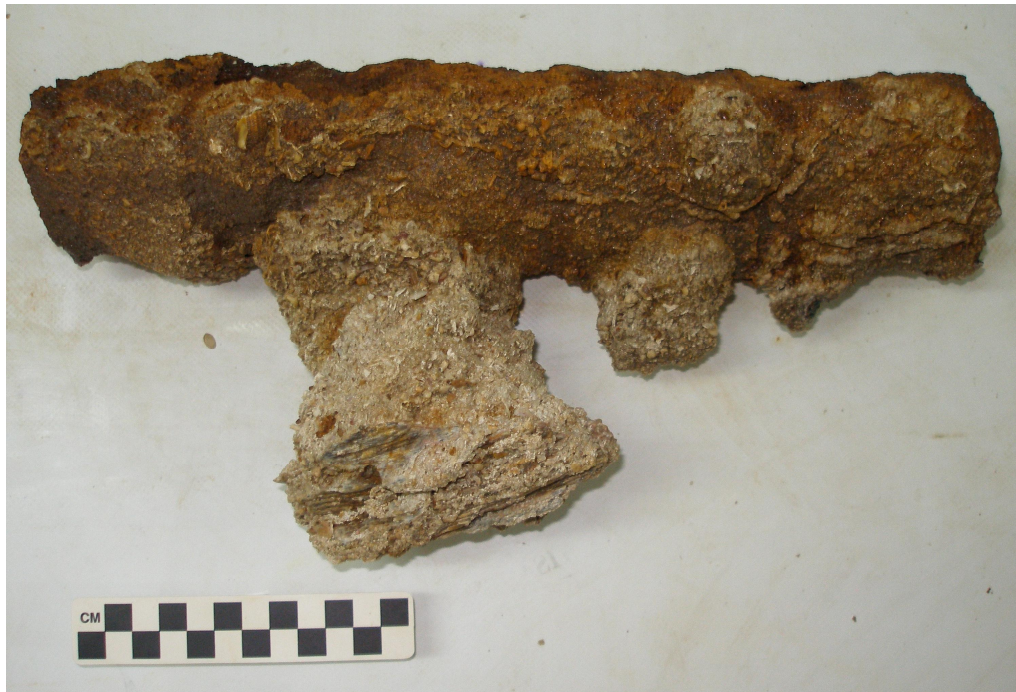
Fig. 2.6: ABX-4, with wood remains visible on largest protrusion.

ABX-4 (Fig. 2.6) was a smaller portion of the anchor's shank and was attached to ABX-5. Its cross-sections were again diagnostic in that where it connected to ABX-5, the shape appeared octagonal, but where it joined ABX-3, the cross-section was rectangular. There was substantially less sediment at the ABX-5 joint as well, making it easier to see the inner wall of the void, and although difficult to define in places, there seemed to be metal lining the interior. Like the other fragments, it was packed with sediment, although it was possible to see through the length of the concretion via a very small hollow. Two large unidentified concretion nodules formed on the underside of the section, and it was thought that they were a result of heavy concretion and not key to the identification of the artifact.

There were two nails attached to the underside of the section as well, although it seemed that their attachment occurred as a result of being caught in the anchor's immense encrustation, and that they did not serve a function in relation to the anchor itself. There was wood, or the imprint of wood, concreted to the underside of the largest nodule – the portion that was buried deepest in the sand. It was near this imprint that a third nail was noted, indicating that the wood and nail were likely associated and probably indicative of hull remains.<sup>25</sup>

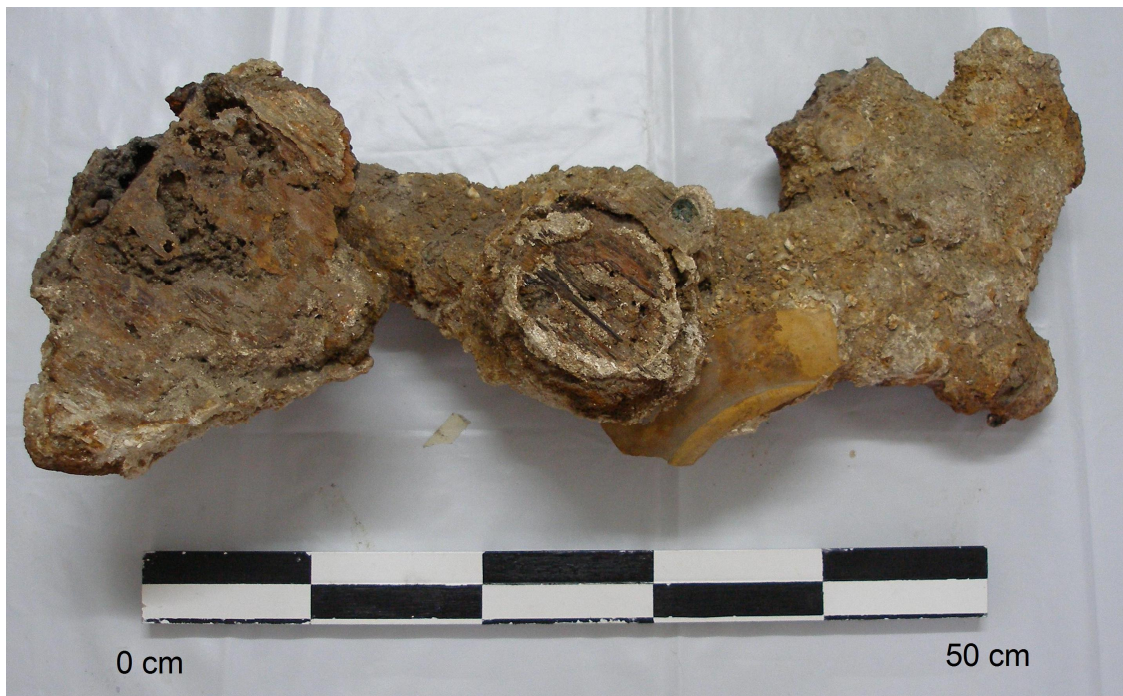
Fig. 2.7: The underside of ABX-3, with visible wood, nail, and ceramic fragments (photo by J. Levin).

of the anchor, as it was lying in situ (Fig. 2.7). The iron corrosion preserved a large fragment of wood on the underside of the arm at the tooth and a smaller fragment midway down the same arm. There were also two fineware ceramic sherds attached to that arm, one medium and one tiny. The medium sherd was newly broken and contains a portion of the vessel's rim, and the smaller sherd is painted with a faintly visible pattern. Within this segment, the sediments were densely packed, but it seemed there might be fragments from the surface of the anchor within the concretion when loose chunks of iron were found to be detached from it. The length of ABX-3, measured from the crown of the anchor to the tip of the still-attached arm, was 57.4 cm.

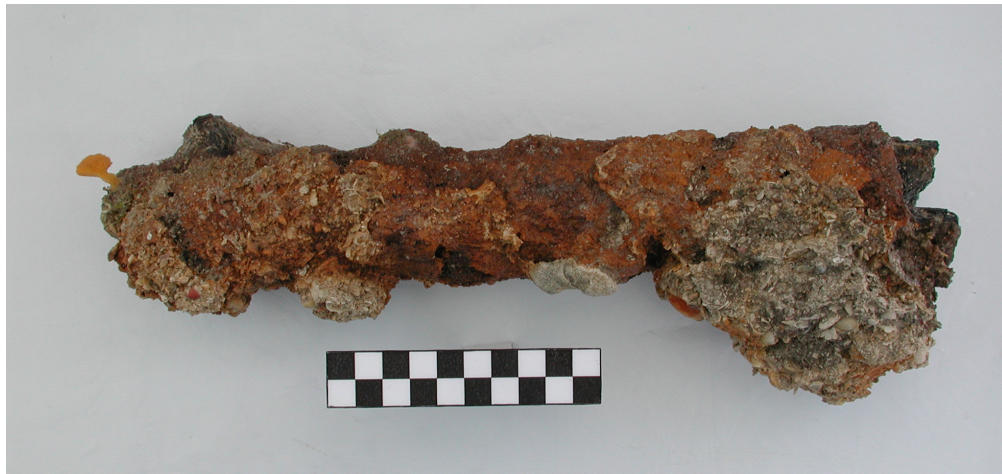
Fig. 2.8: ABX-2.

Finally, ABX-2 (Fig. 2.8) was the most manageable section, and thus one of the first to be raised from the seabed. It is the right arm, broken away from ABX-3 very near the crown. Within the break, iron remains were found lining the upper and lower surfaces of the void. As with the other sections, there was thick concretion on the underside, consisting of white crumbly material made of loosely packed sand and small seashells.

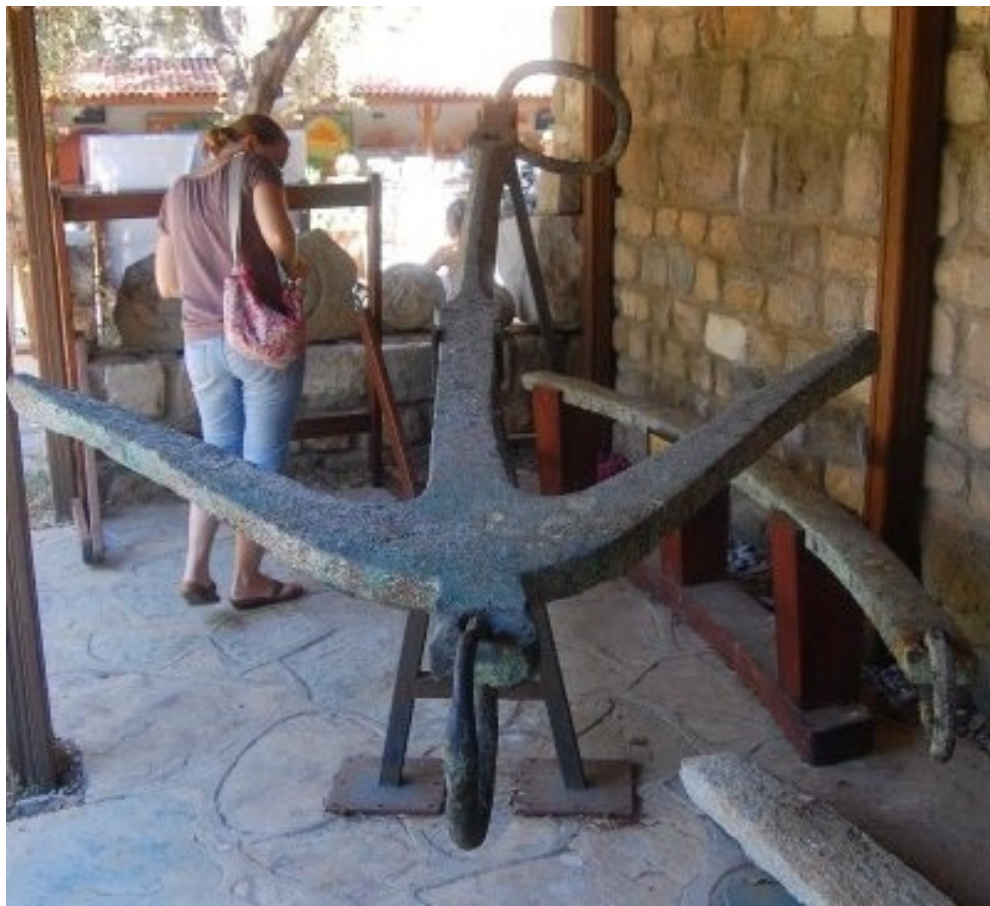
Fig. 2.9: Bronze anchor from the Bodrum Museum of Underwater Archaeology, with associated stock (right) showing clear curvature (photo by J. Littlefield).

supported by the fact that the bronze anchor stock in the Bodrum Museum has a pronounced curvature (Fig. 2.9), explaining the curvature visible in the adjoining sections ABX-6, ABX-7, and ABX-8. It was also verified by studying the shape of the cross-section of the fragments in the laboratory in 2008. It had no indication of a change in shape, as seen in the anchor, and remained rectangular throughout.

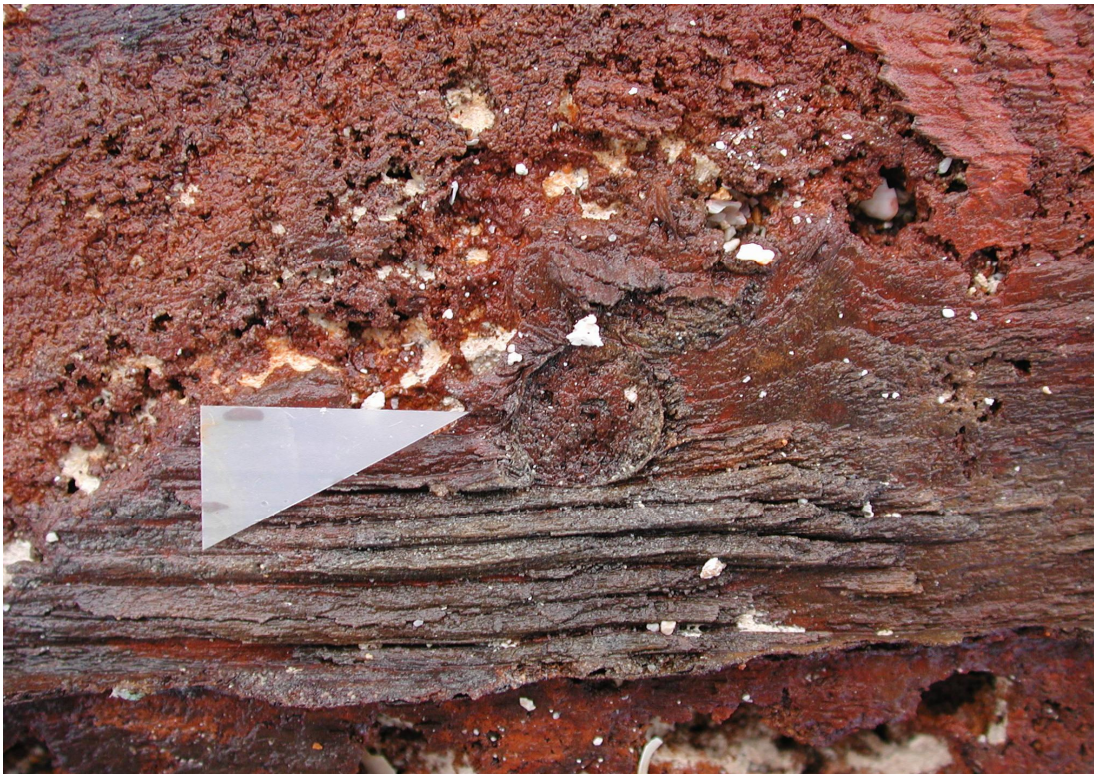
Fig. 2.10: Wood remains attached to ABX-7 and what appears to be a peg (photo by J. Levin).

planking. Within the concretion, the planking left an impression, along with impressions of a seam between two planks as well as a peg, characteristic of mortise and tenon joinery (Fig. 2.10). There was also one ceramic fragment preserved in the concretion. The substantial encrustation surrounding the wood remains was closely examined for additional artifacts, such as nails or ceramics, and object voids indicative of other iron artifacts, but none were found. Metal remnants within the break between ABX-7 and ABX-8 were very loose, and some fragments became detached during initial inspection.

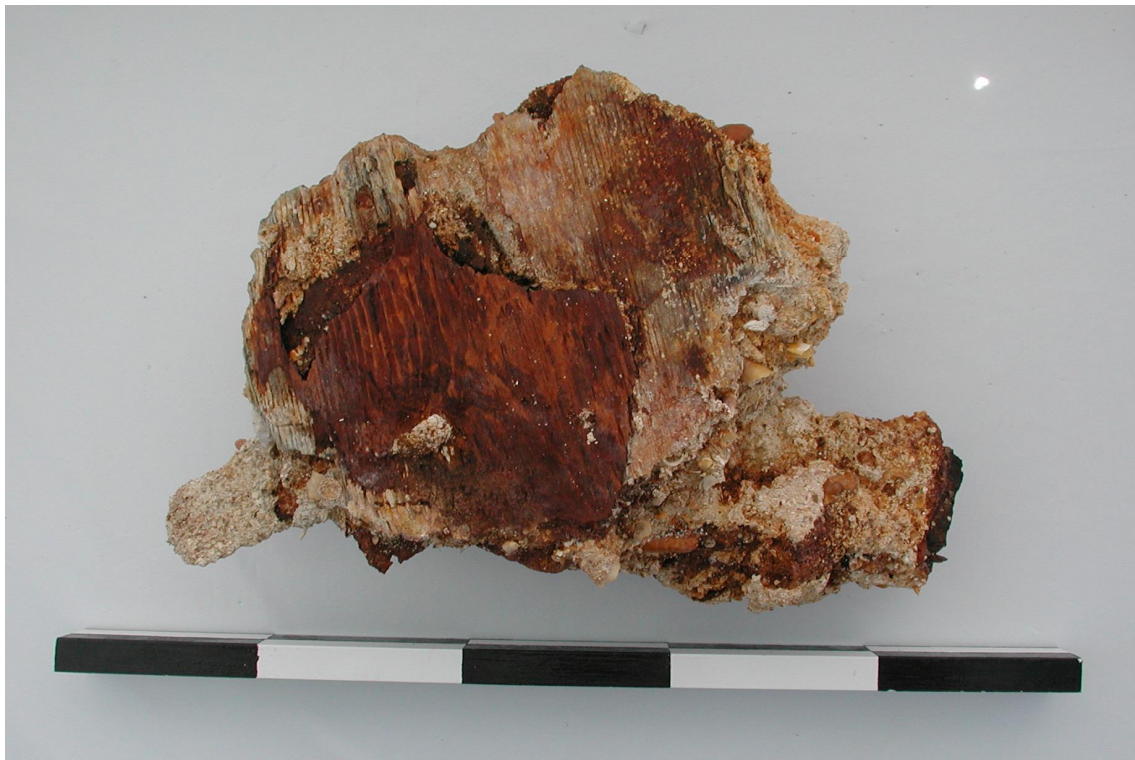
Fig. 2.11: The underside of ABX-8 (photo by J. Levin).

The terminus of the stock was ABX-8. It was a smaller section, and its globular shape can be attributed to the end of the iron corroding downward toward the planking of the ship, a portion of which was still attached to its underside (Fig. 2.11). There was also a small projection at one end, perhaps another object, but its identity remained unknown until mechanical cleaning could commence. Being that the concretion was so dense, it was difficult to attain a decent x-ray image of this section, so cleaning proceeded cautiously.

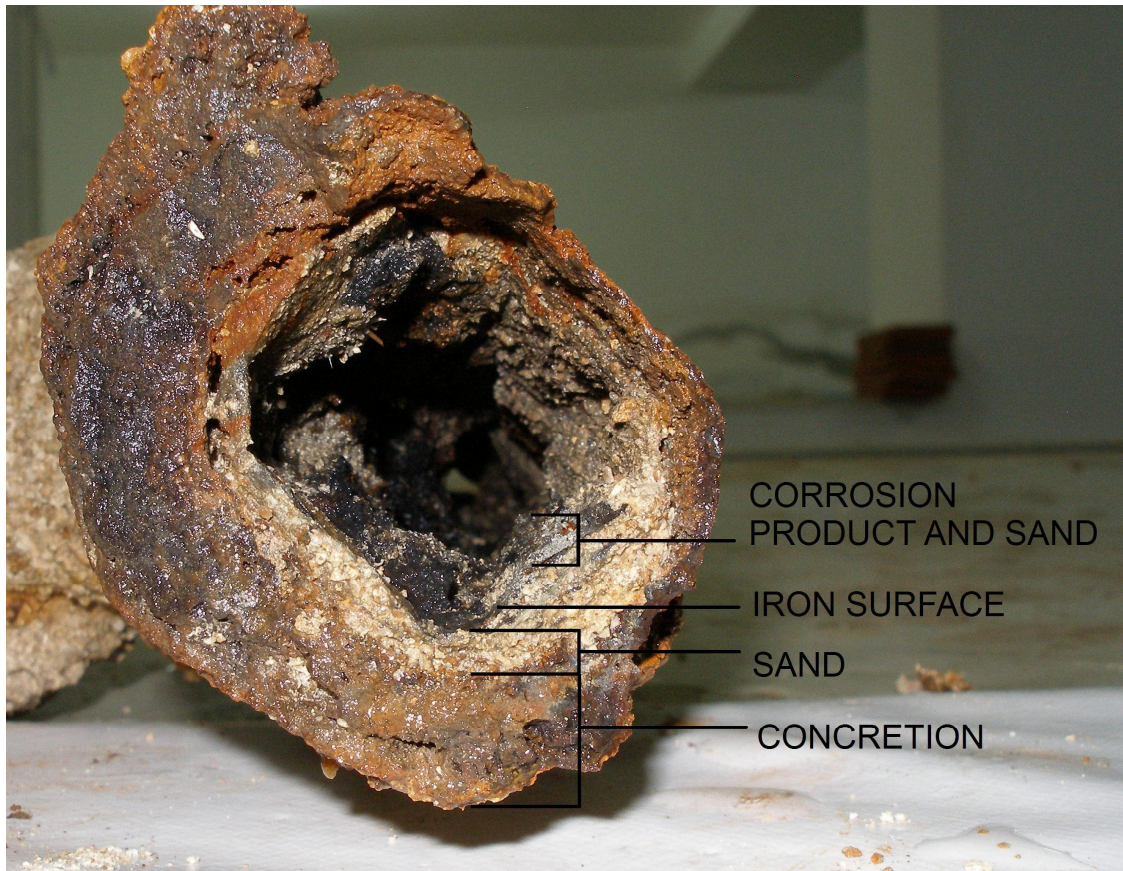
Fig. 2.12: Close-up of the break between ABX-4 and ABX-5. A thick wall of concretion surrounds a thinner layer of hardened sand, and the void as well is packed with sand and black dusty corrosion product, with the thin layer of iron clearly showing the central shank's octagonal shape.

anchors from the 11<sup>th</sup>-century C.E. shipwreck at Serçe Limanı, Turkey.<sup>27</sup> However, the surface of the Kızılburun anchor was incredibly flaky, fugitive, delicate, and problematic during conservation. It was necessary to fully remove the internal sand to produce a good cast, and this led to further degradation of the iron, as it seemed in places that the sand was the only thing holding the original surface layers in place (Fig. 2.12).

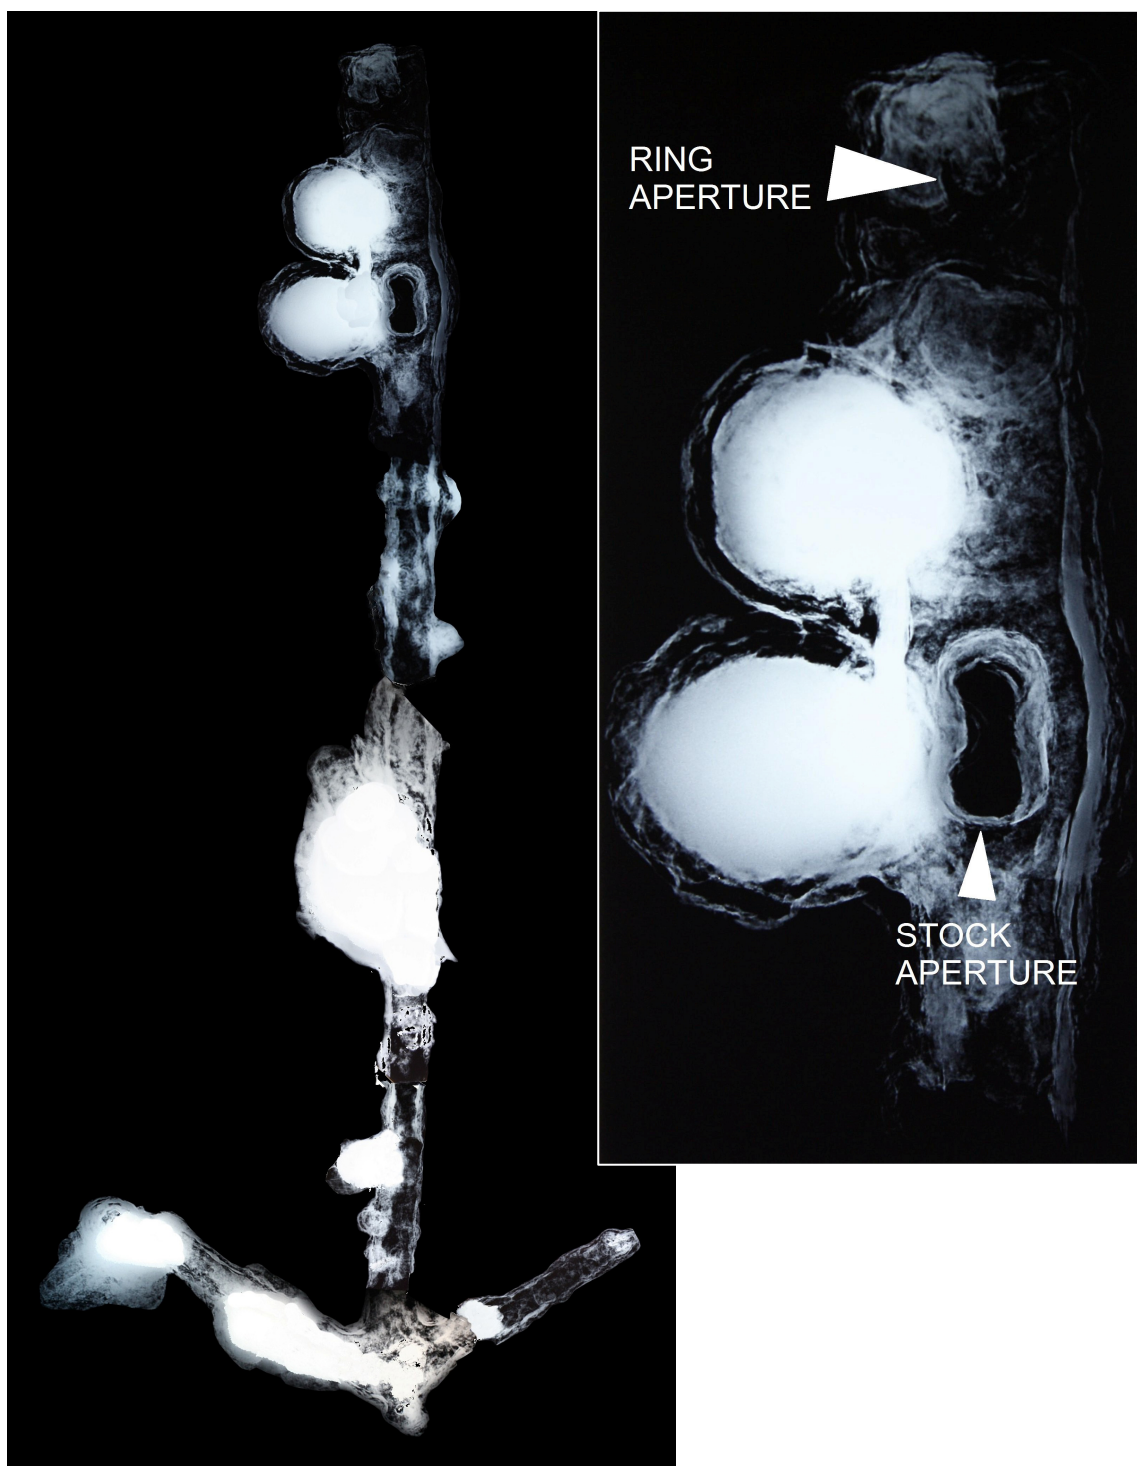
Fig. 2.13: X-rays of the individual sections stitched together (left), and x-ray of ABX-1 (right). Outline of object and apertures for ring and stock are clearly visible with dense concretion, impenetrable to radiography, appearing white.

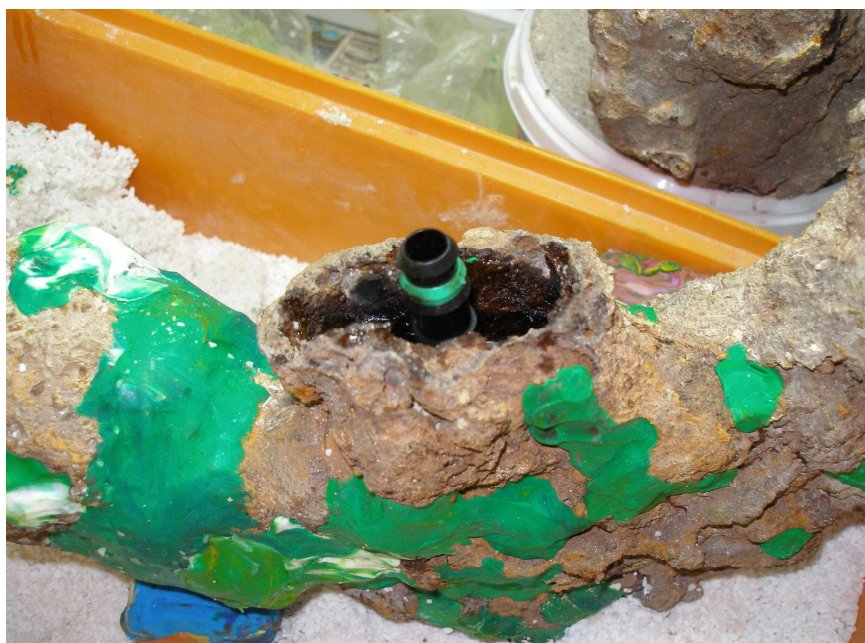
Fig. 2.14: Close-up of black plastic bracket mounted in the break between ABX-3 and ABX-4.

hollow cylindrical piece of plastic, only slightly larger than the brass rod, with ridges along the outside, to keep it steady and in place. Epoxy was poured around the outside of the bracket, beginning with a small amount that was allowed to set up around the plasticine to prevent it from leaking into the empty inner hollow where the brass rod would be inserted. After allowing that to harden, it was deemed safe to add more epoxy until the epoxy level reached just below the break.

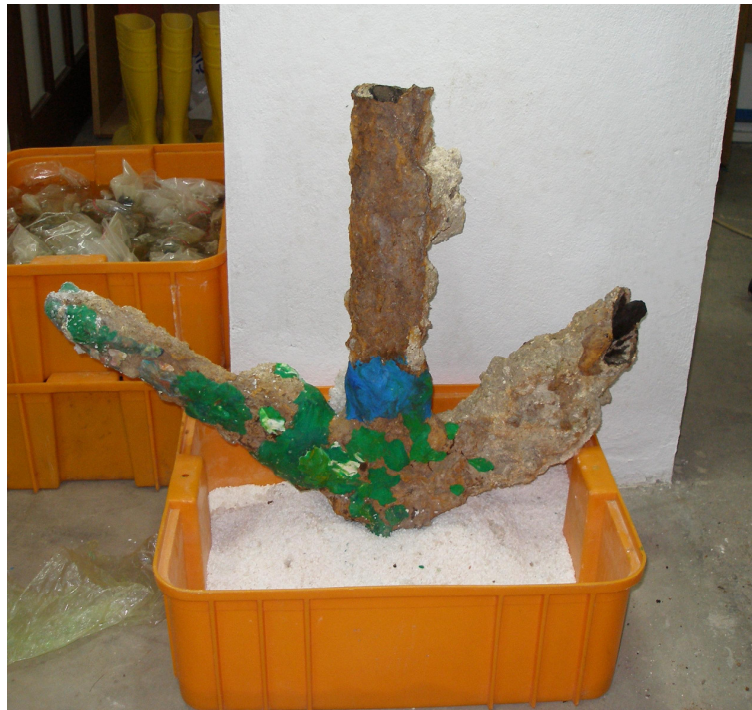
Fig. 2.15: ABX-2, 3, and 4 assembled.

would have to be addressed as they appeared. Again, the break between ABX-3 and ABX-4 was completely bridged with plasticine (Fig. 2.15). Following the secure reconnection of the joint, the brass rod was gingerly threaded down the length of ABX-4 and inserted into its bracket, without touching the walls of the concretion (Fig. 2.16).

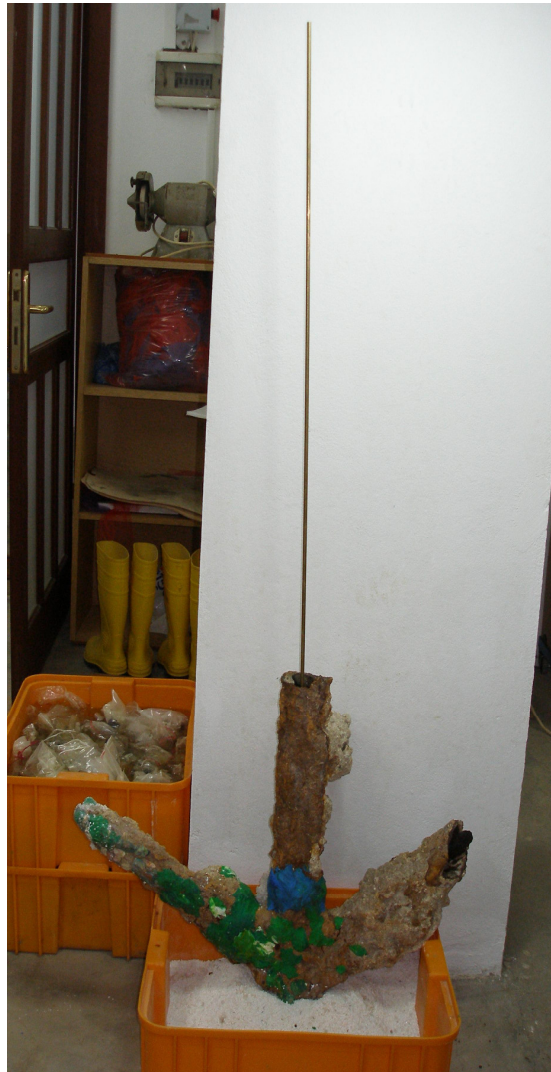
Fig. 2.16: ABX-2, 3, and 4 after mounting the brass reinforcement rod.

The plasticine ball holding the bracket in place retained enough elasticity so that it formed around the rod, and the rod did not shift after insertion. Batches of epoxy were poured into ABX-4, filling the cavity as well as the space between the bracket and the brass rod assembly, creating a permanent seal between the two. Meanwhile, the numerous leaks were plugged with more plasticine as quickly as they appeared. In retrospect, many leaks might have been avoided if the concretion had been consolidated by painting the outer surface with epoxy, Paraloid B72, or even a polyvinyl acetate emulsion.

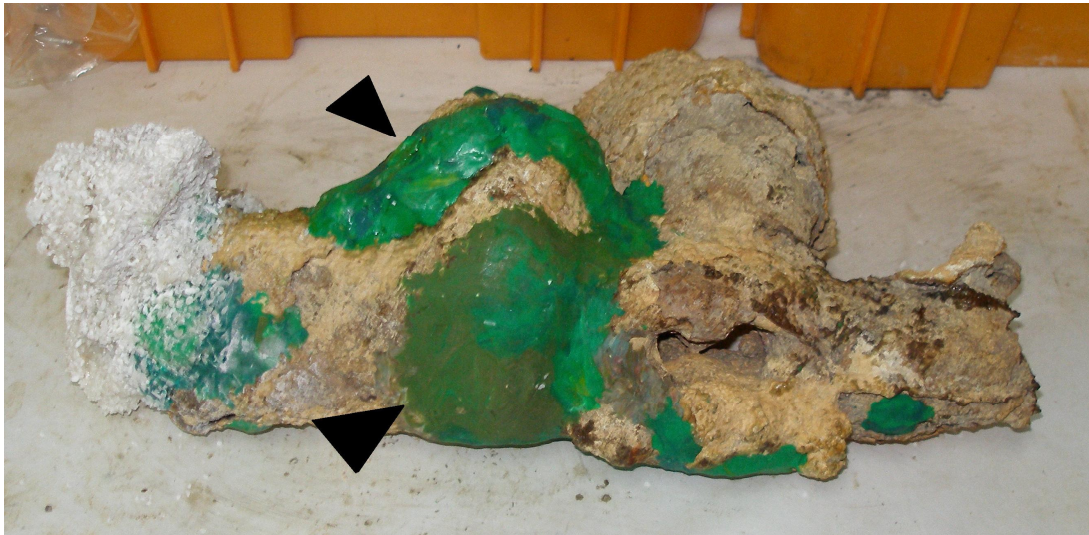
Fig. 2.17: ABX-1 following its reconstruction. Arrows indicate the extensive amount of plasticine used to plug the copious leaks.

It was now time to turn attention to the most time-consuming pieces at the very top of the anchor (Fig. 2.17). Because of the tight inner spaces, it was necessary to break ABX-1 into two sections, right between the apertures for the stock and the ring. This was done by inscribing a line with a pneumatic chisel, or air scribe, around the desired breaking point just through the outer layers of concretion, followed by concentrated chiseling. Instead of breaking straight through, as was desired, the piece cracked in a diagonal manner very near the stock aperture, with some small fragments of concretion becoming dislodged. Although this did not happen exactly as planned, the break enabled thorough removal of the sediment. The inner walls throughout ABX-1 were determined

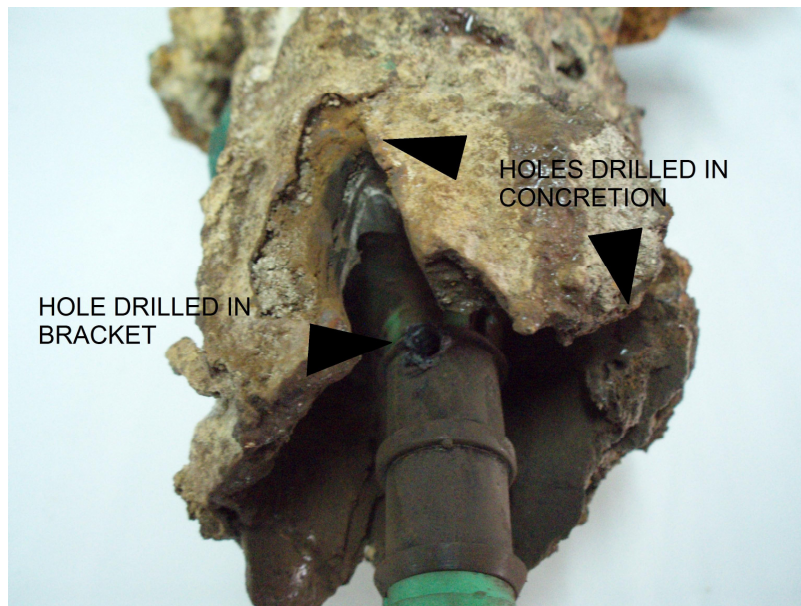
Fig. 2.18: Mounting bracket for reinforcement rod in ABX-1 with holes drilled in bracket and concretion to reduce air bubbles in cast.
